Management of Customers' Complaints within SC COMPA SA Sibiu. Case Study for a Topical Complaint

Processing the complaint "Shape of the hole for D0,87 NOK".

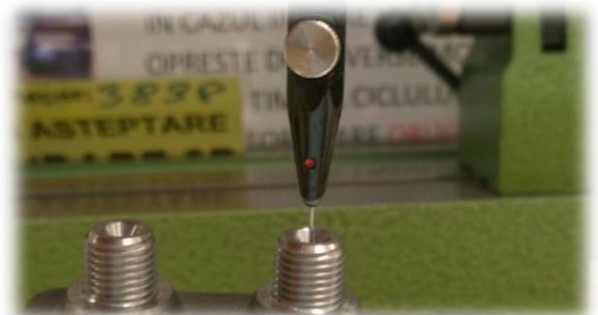
Figure 2. Gauge check of good piece

In the image (Figure 2.) above we have a D 0.87 conformity check of a high-pressure nozzle, a check performed with the No Go tool of the gauge. It is noticeable that between the face of the high-pressure nozzle and the body of the Go/No Go gauge there is a distance of several mm.

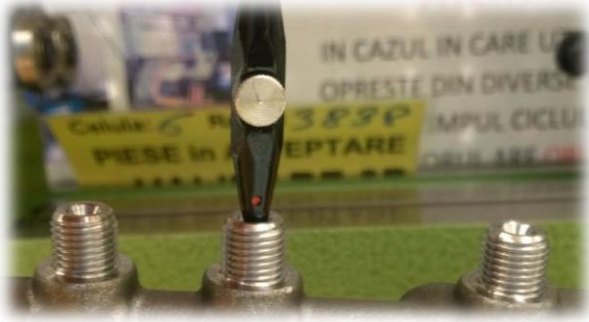
Figure 3. Gauge check of the piece subject to complaint

Following the visual check made by the customer, workshop's Quality Department was notified concerning the identification of a product presenting one of the D 0.87 holes as being NOK (3-HP3 high-pressure hole). Upon Go/No Go gauge check this nonconformity was confirmed.

The image above (Figure 3.) shows confirmation for the D0.87 nonconformity of the piece subject to complaint by the fact that there is no distance between the face of the high-pressure nozzle and the No Go part of the gauge.

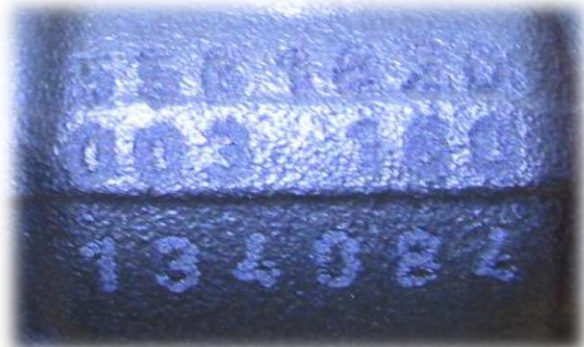
Figure 4. Identification data of the piece

The Compa workshop took over this part (Figure 4.) and based on the analysis on the marking of the piece, traceability was reconstructed, which, according to ISO 9000:2005 consists in presenting the requirements to which an organisation must respond in order to be able to identify a product/service launched for fabrication and throughout its entire production.

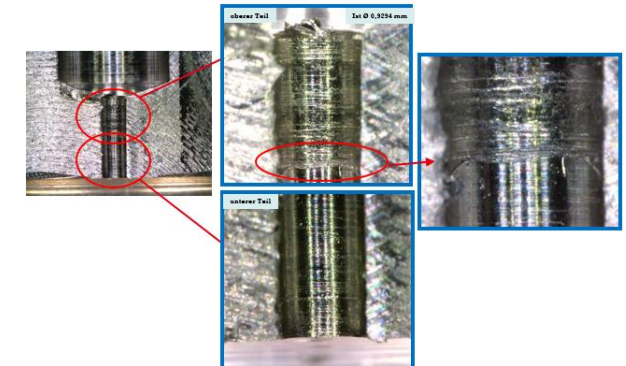
Figure 6. Microscope analysis HP4 with D0.87

The first piece analysed was the piece subject to complaint having nonconforming D0.87. Below, a cross-section of the piece from the complaint - under microscope (Figure 5.). After the microscopic analysis, it was noted that the hole from the complaint presented two distinct sectors, with different properties, as follows:

- the upper sector of the hole (first half) has a “V”-shaped conicity and on the basis of this conicity there is an elevated degree of marked scratches.

- the lower sector of the hole subject to complaint is cylindrical in shape and has a better roughness of the surface compared to the upper sector.

However, on both sectors can be identified screw scratches on the entire cylindrical part of the hole (Figure 6.).

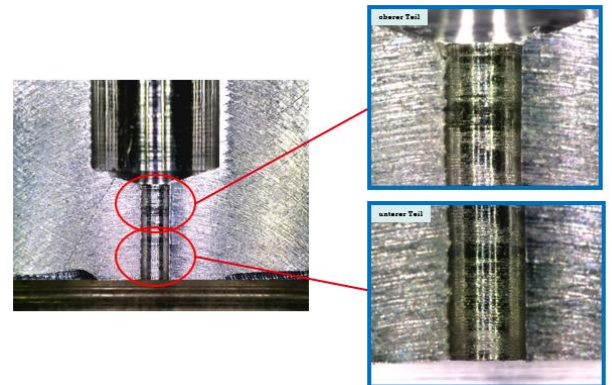
Figure 7. Microscope analysis of NOK piece

Unlike the first piece, the shape of the hole is cylindrical, there is no shape deviation (Figure 7.). However, on this hole too there are screw scratches. Another difference compared to the first piece was represented by the fact that on this third piece, ALL HP holes were outside tolerance range (holes were larger).

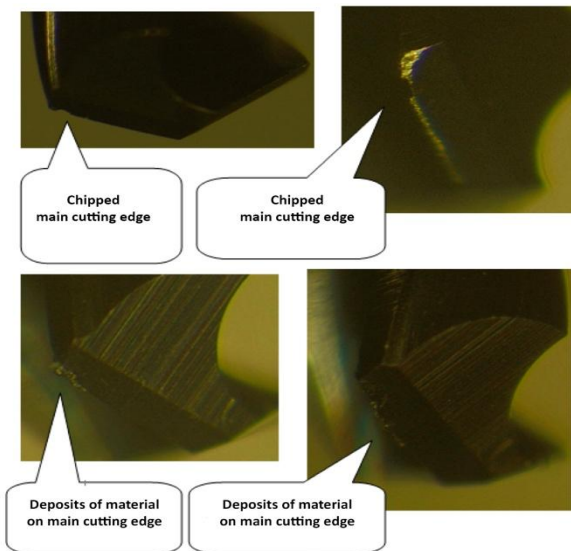
Figure 8. Analysis of the drills under microscope

The same types of phenomena could be identified on the majority of the checked drills, namely, deposition of material on the edge and chippings of these edges. The chippings are predominantly on the main metal removing edges, towards the intersection with the secondary metal removing edges (Figure 8.)

-the depositions on the edges were generated by insufficient removal of the chips generated in the process;

-during processing, a high level of heat is generated, which is amplified by inefficient cooling at the level of the tool's edge;

-the work advancement is insufficiently choosing (the drill presents a higher level of friction with the material because of the work advancement which is too low F0.04, F0.03 respectively for the two types of drills).

Implementation of a cooling notched sleeve in order to direct more efficiently the flow of cooling liquid towards the metal removing area (see photo);

Increase of pressure of the cooling liquid through the two broaches of the CNC machine;

The increase of the work advancement to F0.055 from F0.04, F0.03 respectively for the two types of drills D0.87.
